HEAVY LIFT HELICOPTER - ADVANCED TECHNOLOGY COMPONENT PROGRAM - HUB AND UPPER CONTROLS. **Bosing Vertal Company** P.O. Box 16858 Philadelphia, Pa. 19142 Final Repert Jul 371- Jul 32075 Approved for public release; distribution unlimited. Prepared for DAAJO1-71-0-4840 U. S. ARMY AVIATION RESEARCH AND DEVELOPMENT COMMAND P.O. Box 209 St. Louis, Mo. 63166 APPLIED TECHNOLOGY LABORATORY U. S. ARMY RESEARCH AND TECHNOLOGY LABORATCRIES (AVRADOM) Fort Eustis, Va. 23604 403 682

The ATC hub and upper control component development/demonstration activities included the flap/lag pitch elastomeric bearing, frequency selective lag damper, and shear bearing development efforts; manufacturing techniques development; fretting inhibitor evaluation; safe-life, fail-safe, and endurance testing of major hub and upper control components; whirl tower tests; and integrated rotor-drive system tests.

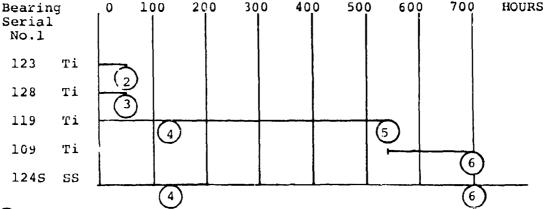
- Shim material indicated thus: Ti-Titanium, SS- stainless steel
- Testing terminated at 52 hours because of substantial abrading of elastomer between shims
- Testing terminated at 52 hours because of substantial abrading of elastomer between shims, and permanent set (axial bowing) of laminates

- Centrifugal force reduced at 128 hours to 121,000 pounds to be representative of the average compressive stress on the 10-inch bearing
- Testing terminated at 532 hours because of gross abrading and squeeze out (extrusion) of elastomer. New bearing installed.
- 6 Testing terminated at 700 hours to start tests on 10-inch bearings.

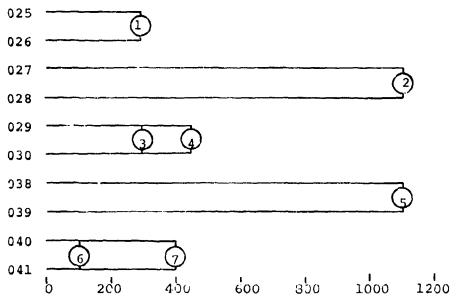
- 1 Testing terminated at 300 hours because of poor condition. Testing conducted with one large floor pedestal fan blowing on bearings.
- Pesting terminated at 1100 hours. Bearings declared worn out. Testing conducted with smaller blowers directed at several points on bearings.

- (3) Completed 300 hours pre-endurance testing at ambient conditions same as bearings 027 and 028.
- Test terminated at 420 hours (120 hours of 120°F) by machine shutdown. One bearing was separated-bond failthe accelerated by high temperature.

- Testing terminated at 1094 hours. Bearings declared worn out. Thermocouples installed on one bearing at beginning of test indicated temperatures for one and five hour blocks (see Figure 47). As a result, block time changed to one hour.

- 6 Completed 100 hours pre-endurance. Pre-endurance time reduced from 300 hours because of success with previous bearings in pre-endurance.
- 7 Testing terminated at 400 hours (300 hours planned at -65°F)

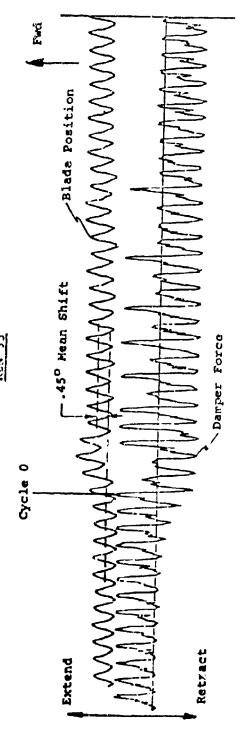
IGURE 51. WHIRL TOWER DATA - FREQUENCY-SELECTIVE DAMPER

A hunting or limit cycle phenomenon in which there is alternately a loss of tension and compression cycle damper force was experienced during the whirl tower test program. This condition is illustrated in the time history of Figure 51. Prior to "Cycle O", the damper is developing load in response to the $1/4\Omega$ blade motion only in the extension (tension) direction. Just prior to "Cycle O" the damper begins to develop load during the retraction (compression) cycle which is followed almost immediately by a forward shift in the blade mean lag position and a loss in extension cycle damper force. At "Cycle 39" the reverse process takes place. It is evident that this switching phenomenon will be repeated, giving rise to an unacceptable low-frequency hunting of the blade about its equilibrium position. Similar results, Figure 52, have been obtained with an effective C.F. spring and an existing analytical model of the damper. The analytical time history differs slightly from the test results in that the condition has been initiated by an impulse at time zero. Displacement of the FSD control valve has been shown for reference purposes and explains the mechanism of the low-frequency oscillation. In response to the initial disturbance, the FSD valve is displaced to one side of its null or center position which unloads the damper during the retraction cycle. In turn, the absence of a

retraction cycle force causes the blade to oscillate about a position aft of its equilibrium position. As the decaying valve displacement approaches its equilibrium position, the retraction cycle forces begin to build up and the blade starts to move forward. Due to the blade inertia, the blade main lag position overshoots the equilibrium position which drives the FSD control valve over center in the opposite direction, causing a loss of extension cycle damper force. At this point, it is apparent that the cycle is repetitive and essentially undamped.

Analytical investigations revealed that the low frequency limit cycle is a function of the leakage area across the FSD drive cylinder. While a complete analysis was performed, there is evidence to indicate that additional overlap in the FSD control valve is also beneficial. Figure 54 shows a comparison between a non-FSD damper and an FSD damper incorporating a larger leakage area. Examination of the damper displacement waveforms

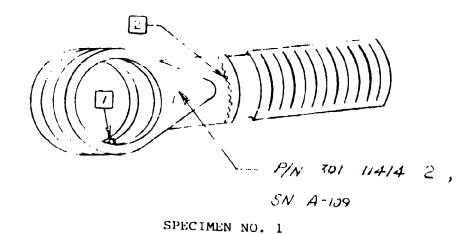
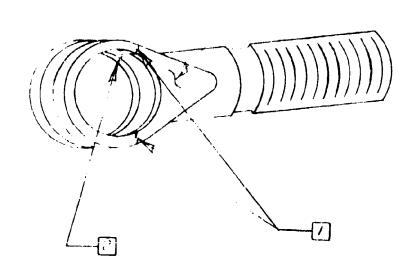
FIGURE 60. LOCATION OF FAILURES - PITCH LINK FATIGUE TEST

The first fatigue failures in both specimens occurred in the outer rod end lugs and were nearly identical in appearance and location. See Figure 60 for the location of failures. Testing was continued after cutting away a portion of the failed lug so that the load was on the remaining lug of the outer load path clevis. The second failure in Specimen No.1 occurred in the shank region of the remaining outer pitch link lug. Light fretting was evident in the lug failure origin areas of both specimens.

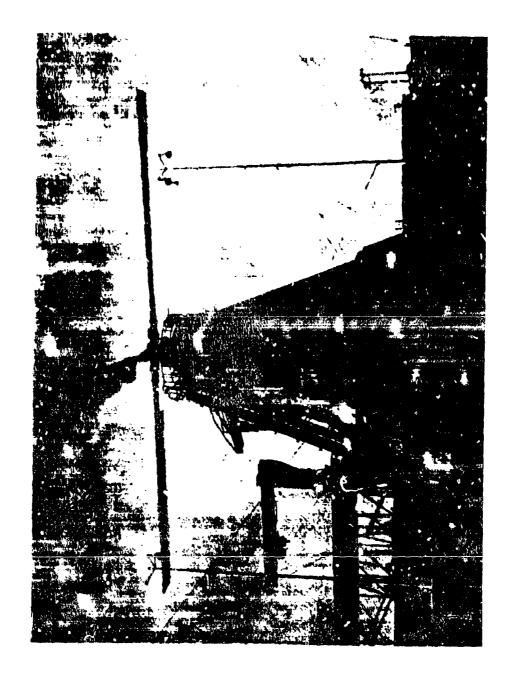
FIGURE 61. HIR/ATC ROTOR ON BOEING VERTOL WHIRL TOWER

A complete rotor hab and upper controls assembly was fabricated and installed with four blades or the whirl tower (Figure 61). A biref whirl test was performed and is reported in Reference 29. Items of the test significant to the rotor bub and upper controls were:

This test revealed deficiencies in the elastomeric bearing, droop stops, and the frequency selective damper. Each of these conditions is described in the detail discussion of that component. The titanium hub retention nut deflected excessively when installed in accordance with drawing specifications. The nut screws onto the rotor shaft loosely, and thrust preload is applied by 28 screws applying force between the nut and the hub. The offset between the shaft threads and the center of the screws produce a moment tending to roll the nut inside out. For the required preload, the deflection of the nut allows the lower diameter to expand and the lower threads to separate substantially. A nut of more substantial cross-section was designed for the DSTR.

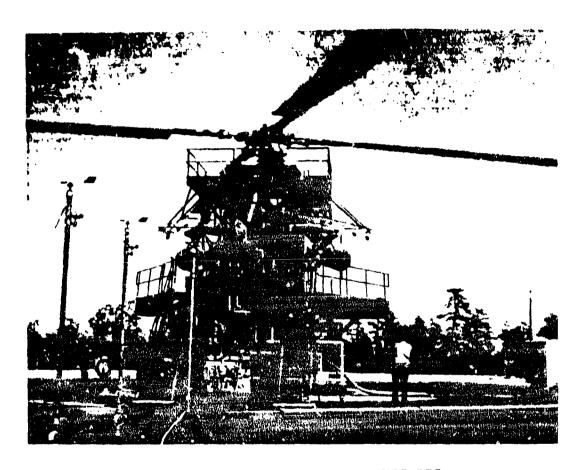
FIGURE 62. DYNAMIC SYSTEM TEST RIG

Upon completion of the whirl test, the demonstration rotor was installed on the DSTR (Figure 62) with engines and transmissions to operate as a rotor-drive system. The tests are reported in Reference 30. The DSTR provided more operating experience to increase confidence in the hub and upper controls while revealing other deficiencies.

Operating problems included tearing of the elastomeric bearing, corrected with the thrust button, and the disengagement of the droop stops, corrected with the cylindrical stop ring. On two occasions, failure of the DSTR (non-aircraft) control system caused substantial damage to the droop stop parts when the control system caused large tlapping motion of the blades while the stop ring was in intermediate positions (between 95 and 115 RPM).

A new problem arose during the DSTR tests that did not occur during the short whirl test. The rotor blade lag damper has spherical bearings at each end and is free to rotate about its axis through these bearings. The fitting to which the inboard end is attached has buttons on either side of the clevis which contact the dumper lug to limit this rotation. Because of the freque, y selective mechanism, the center of gravity of the damper is above the axis and a component of centrifugal force causes a moment about this axis. The limiter button reacts the torque while rubbing due to flapping of the blade and damper. The original Nylon buttens wore severely and were replaced with bronze oilite. These also were rapidly, but it was more expedient to replace the limiters a few times during the test rather than effect a design change. Future rotor heads would not try to correct the rapid wear with other materials, but rather do something to reduce the moment of the lag damper which loaded the buttons.
